Transilvania
University
of Brasov

Ing. Alin-Lucian MIHALACHE

**EVOLUTION OF THE STATUS OF THE TRANSVERSAL
HYDROTECHNICAL STRUCTURES USED IN THE TORRENTIAL
HIDROGRAPHICAL NETWORK MANAGEMENT**

SUMMARY

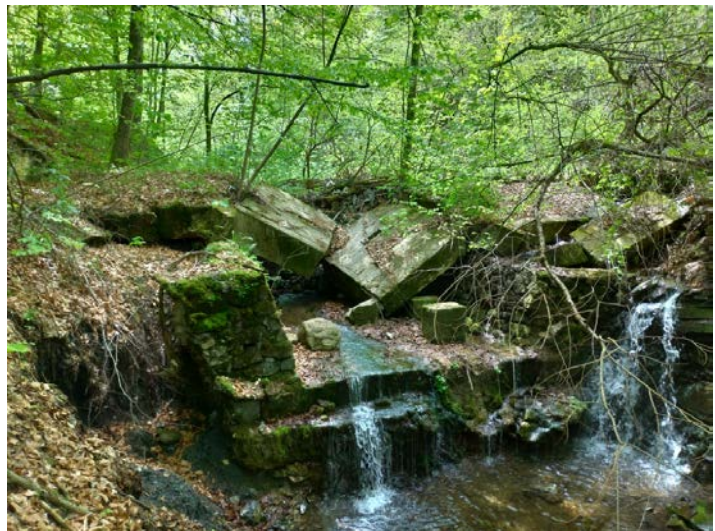
Fig. 2.2. Overturning and breaking of the body of the structure after torrential flow of August 31, 1085

Șanturi Creek – Tărlung basin

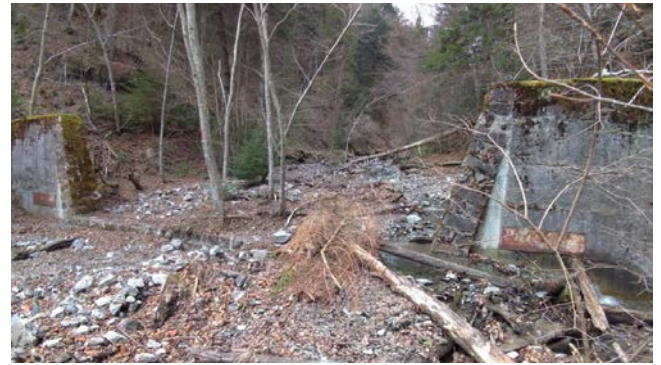
Fig. 5.9. Water course deviation due to apron silting
(Mihalache, 2019)

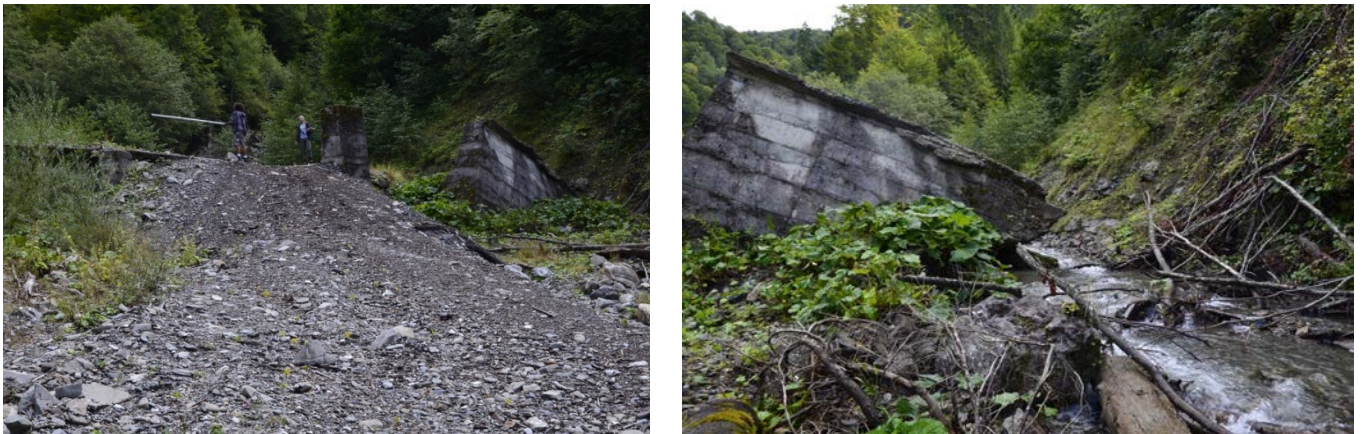
Fig. 5.22. Structure 90 BCF 2.0 - Vinderel Creek

Un embedding represents the behavioral event by which the connection between the wing of the transversal work and the bank where it has its support point is lost. The event is generally caused by bank phenomena (under washes, bank breaks, landslides, etc.) through which the bank in which the work is embedded is washed or dislodged.

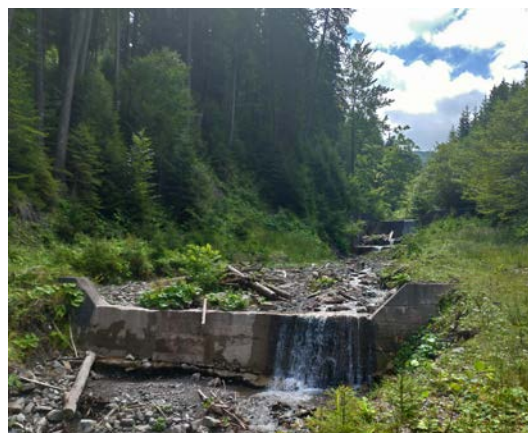
Fig. 5.25. Structure 23 B 0 – Nanului Creek
(Mihalache, 2019)

The undermining average intensity at the first inventory was 0.17, with an average depth of 88 centimeters and an average damage proportion of 77%. The maximum intensity (1.8) was observed at structure 10 B 0 – Tesla Creek, which had a 1.8 meter deep spill over 100% of the spillway opening.

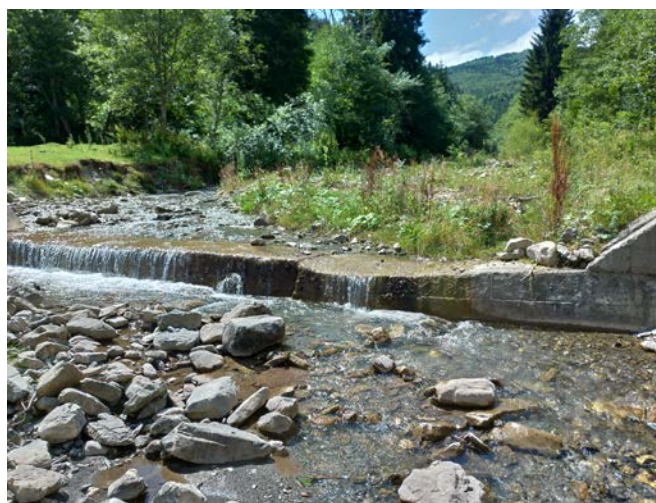
Fig. 5.28. Vertical crack that generated the rupture of the spilled area of the structure 9 B 0 – Tigăi Valley

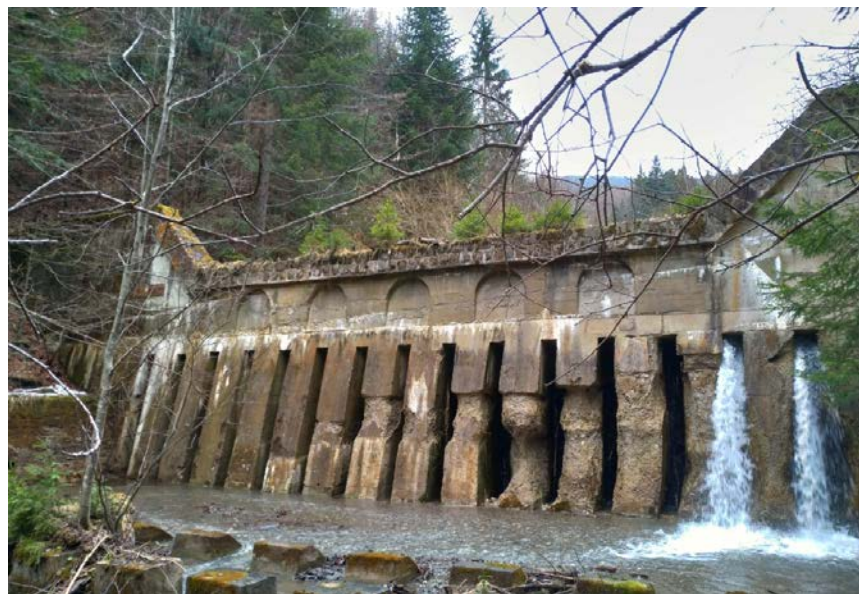
It is caused by the continuous (or intermittent) action of waters loaded with various materials, which lead to the washing and eroding of the materials from which the structures are built. It is mainly localized in the spilled area, which is in direct contact with the torrential waters, the erosion being more frequently at the masonry joints and the concrete layer on the surface of the construction.

Fig. 5.33. Structure 10 BF 5,0 – Tigăi Valley, affected by erosion at the body structure level

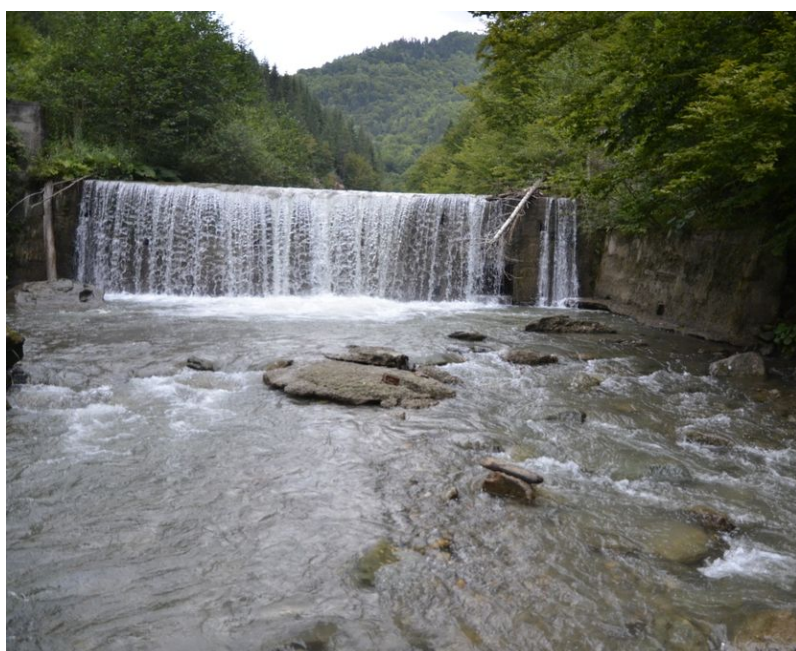
Fig. 5.34. Total apron detachment at structure 3 B 4.0 - Repedea Valley

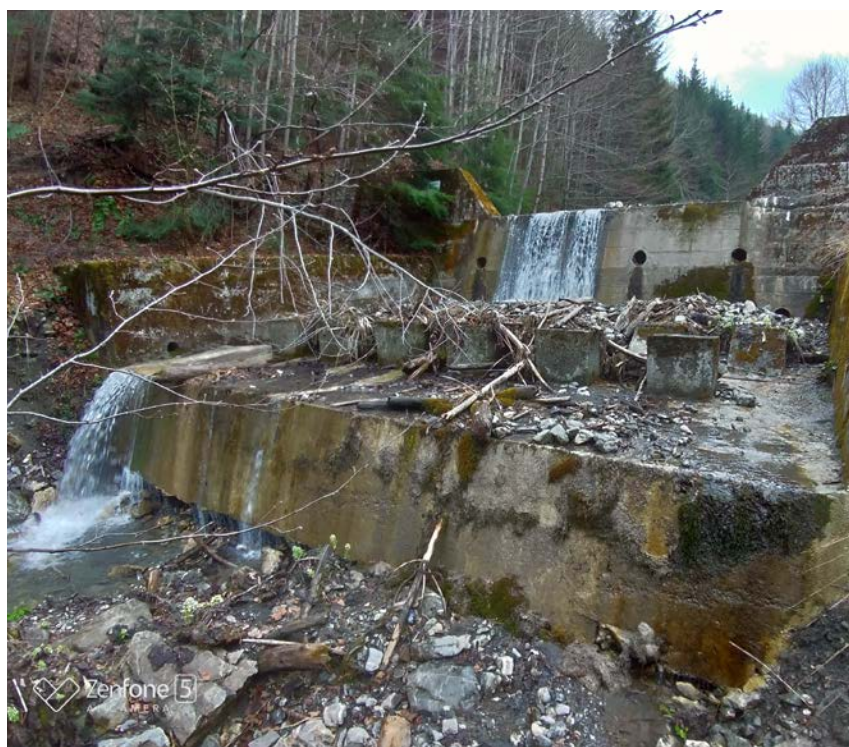
Fig. 5.35. Apron undermining
Structure 11 B 2,5 - Nanului Creek

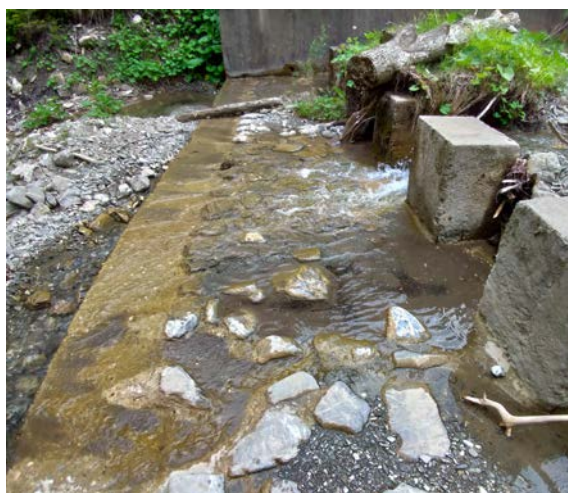
Fig. 5.37. Apron erosion at 11 B 2,0 structure - Tigăi Valey (Foto: Mihalache, 2020)

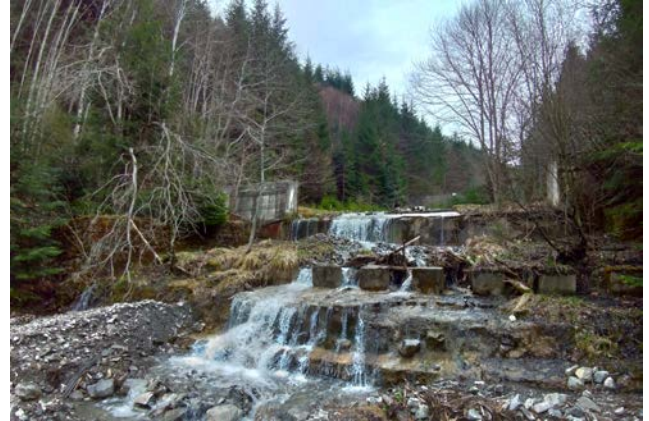
Fig. 5.38. Detachment recorded at the terminal spur
Structure 2 B 3,0 –Nanului Creek

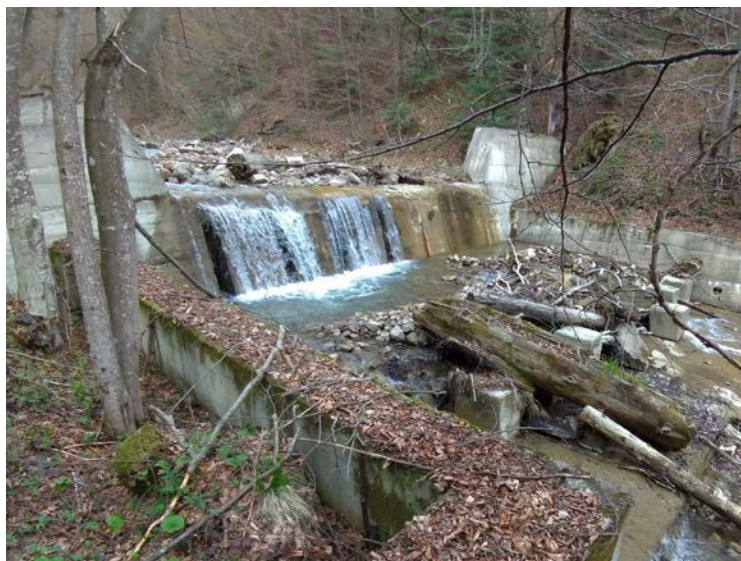
Fig. 5.40. Apron silting
Structure 11 B 2,0 –Tesla Creek
