Transilvania
University
of Brasov

Ing. Alin-Lucian MIHALACHE

**EVOLUTION OF THE STATUS OF THE TRANSVERSAL
HYDROTECHNICAL STRUCTURES USED IN THE TORRENTIAL
HIDROGRAPHICAL NETWORK MANAGEMENT**

SUMMARY

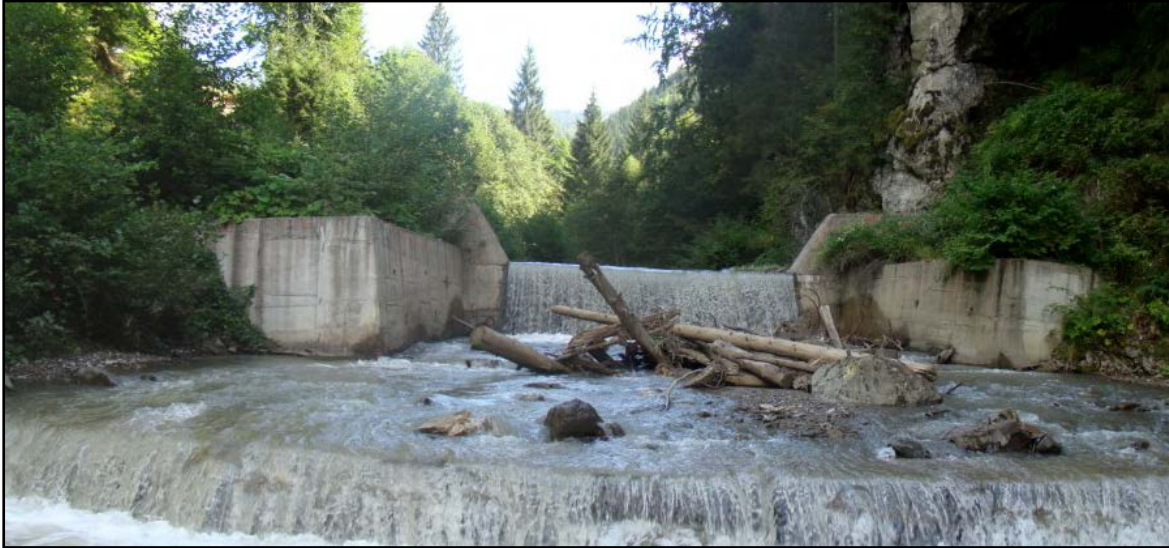
$Y_s = 78,62$ - year 2010

Apron: Detachment – 30%;

Detachment of dissipative teeth – 21/21;

Sedimentation height – 2m.

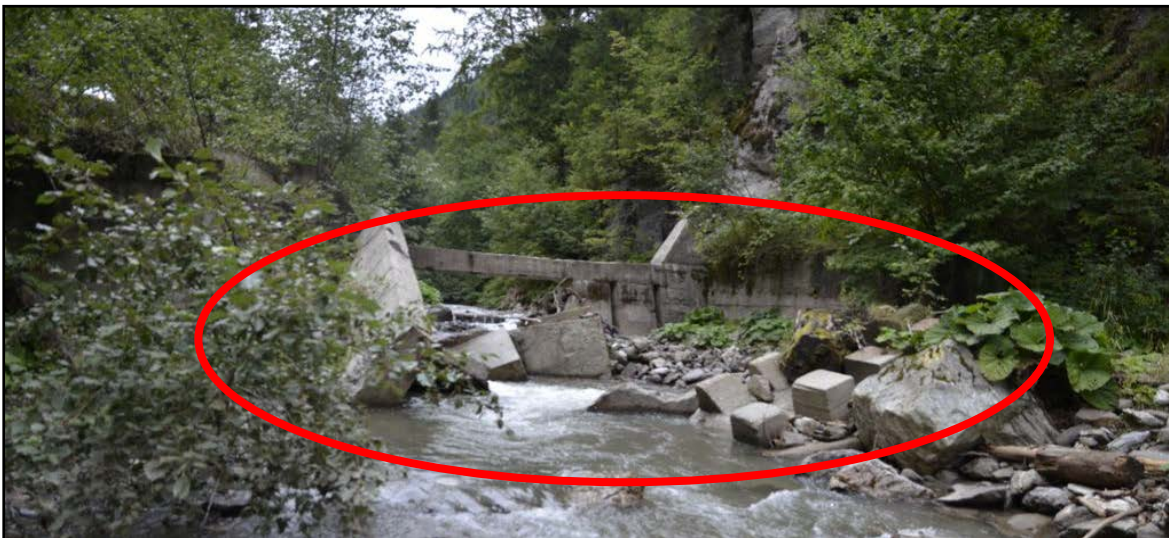
$Y_s = 41,98$ - year 2017

Body structure: Spilled area detachment – 70%;

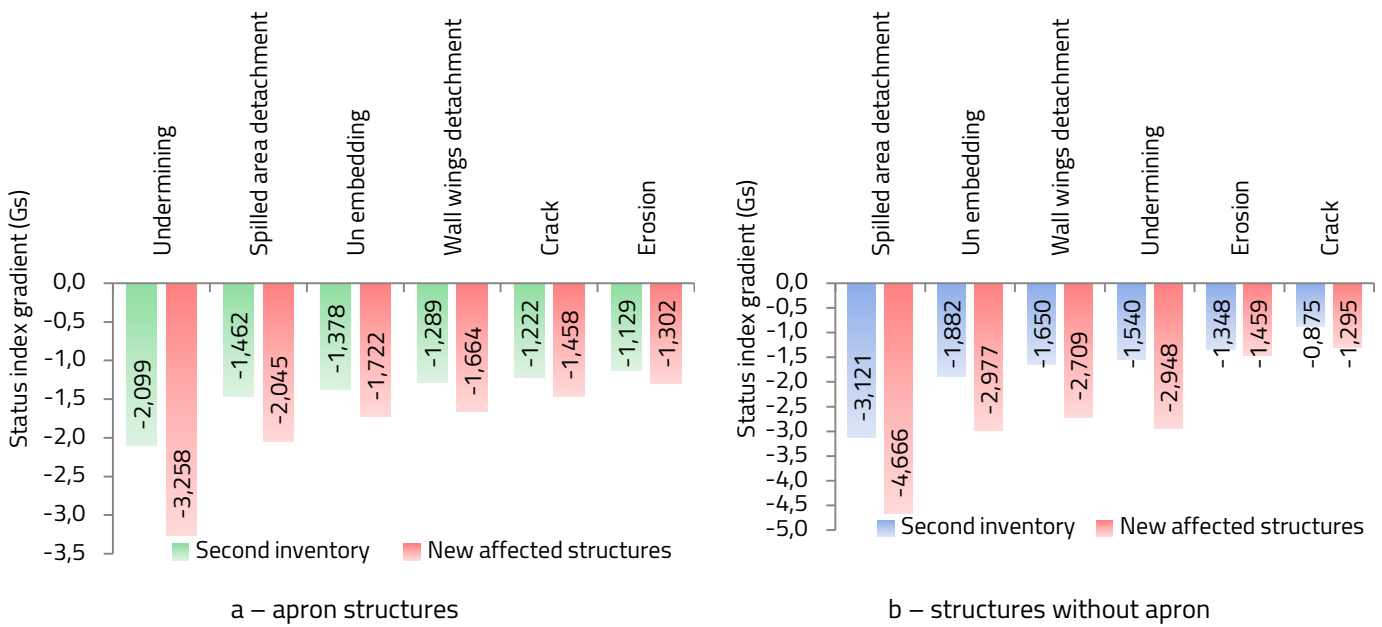
From the point of view of structures affected at the end of the second inventory and the newly affected ones by various behavioral events (Fig. 5.84), the most severe impact to the apron structures was found to be given by the undermining. Detachment in the spilled area also induced a significant impact, the gradient values being -1.462 units/year for the structures that registered damage at the end of the second inventory.

Fig 5.84. Hierarchy of studied damage at the second inventory and at the newly affected parts according to the status index gradient, based on the obtained data

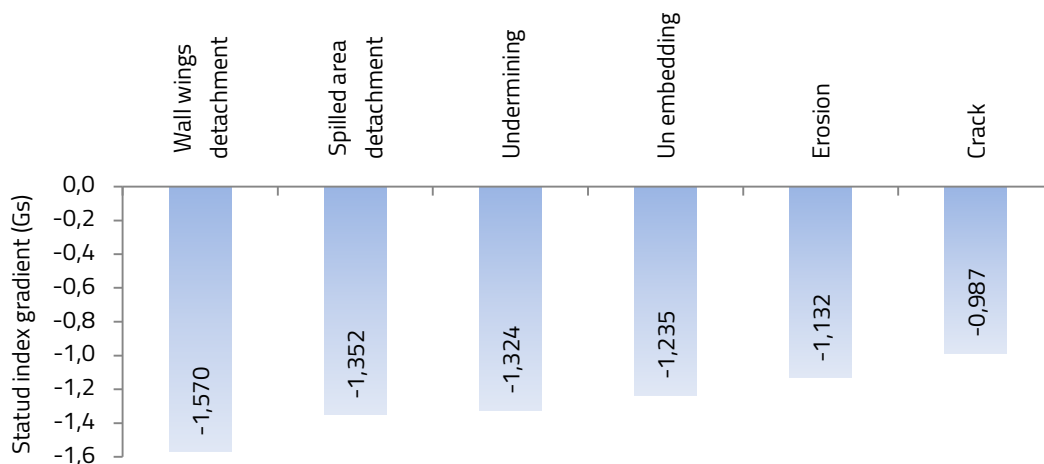
To make the potential use of the status index gradient easier to adopt the investment prioritization decision, a graphic representation based on the pooling of data from both inventories was further used, which highlighted the rank of damages according to the impact of each on the weighted average of the gradient (Fig. 5.85).

Fig. 5.85. Hierarchy of the studied damages according to the weighted average value of the status index
